Industry & Facilities Division  
Third Party Inspection Report

| INSPECTION REPORT No. INS/ER/MSS-24/064-20240627-01 | Revision No. 0 |

| Project: TPI for Ductile iron pipe fittings | IPO Ref (If applicable):N/A<br>(BV internal P/o) |
| Manufacturer/Vendor: HEBEI YONGQIAN TRADING CO.,LTD. | P/o nr:N/A<br>(client to Manufacturer) |

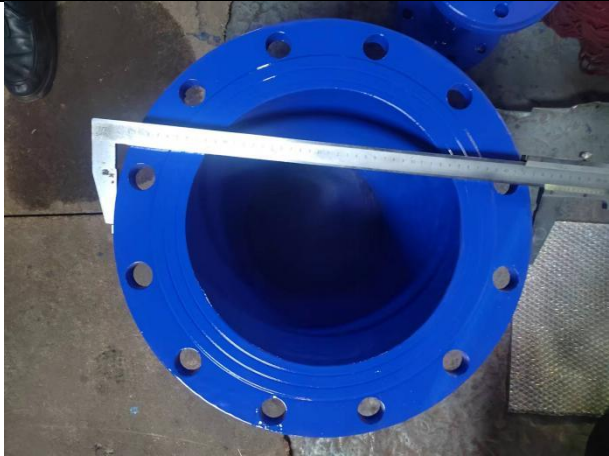
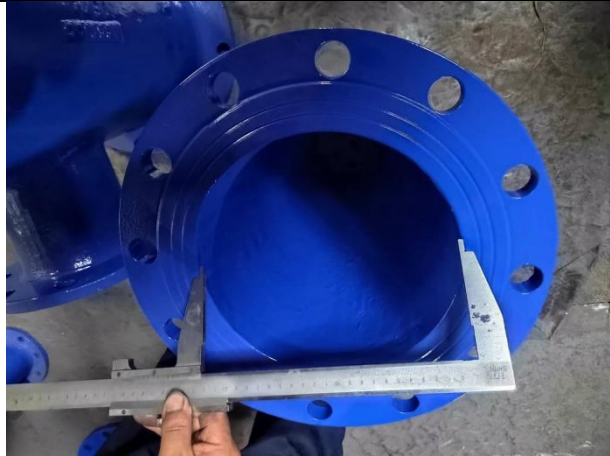
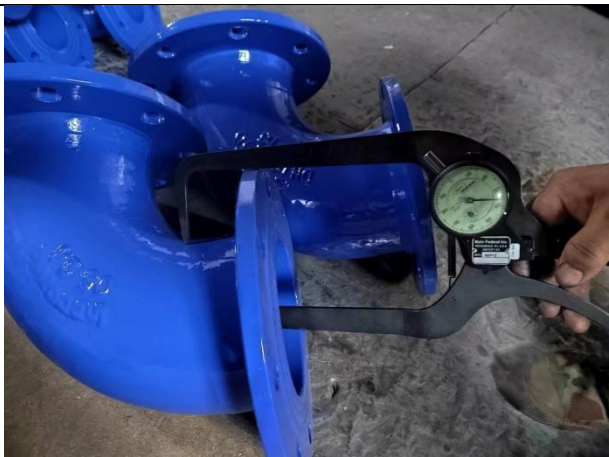
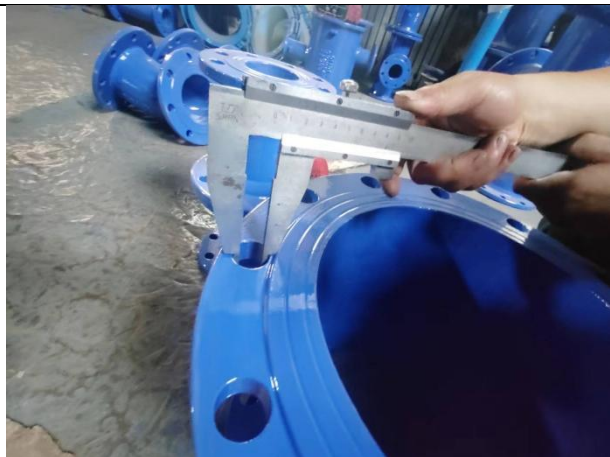
| Description: Dimensional check | Description: Dimensional check |

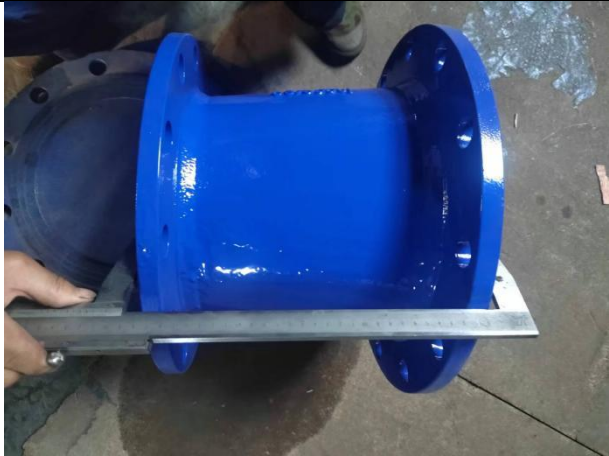
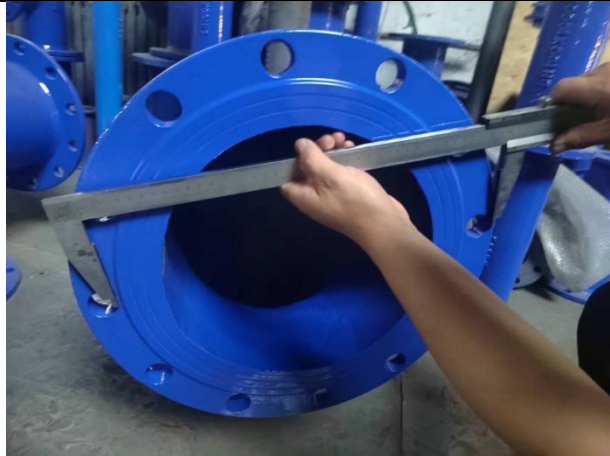
| Description: Dimensional check | | Description: Dimensional check |

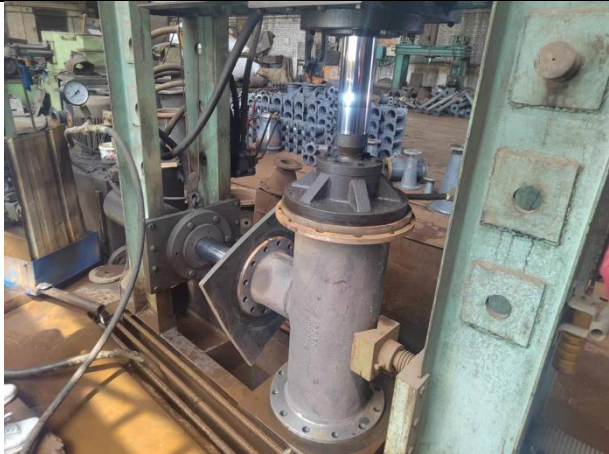
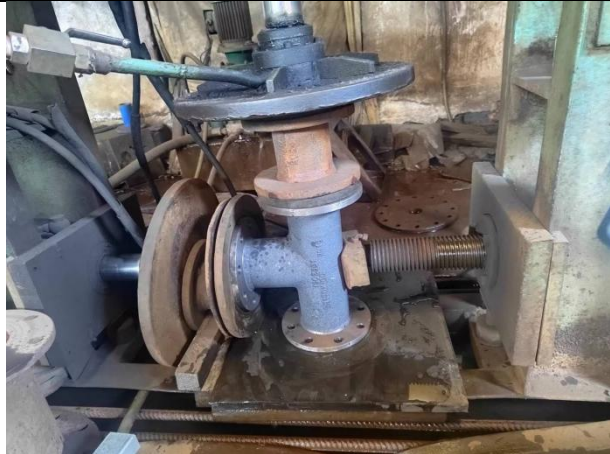
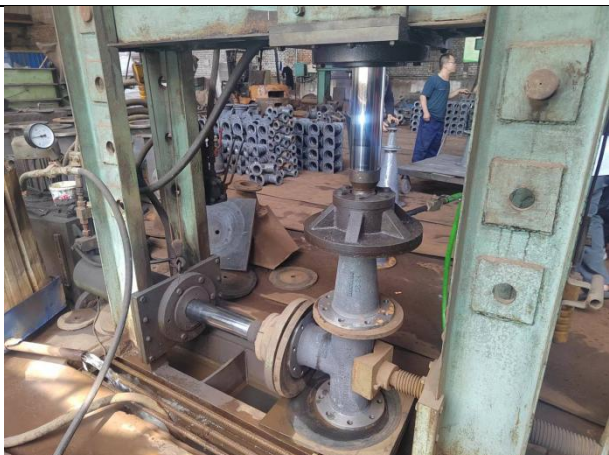
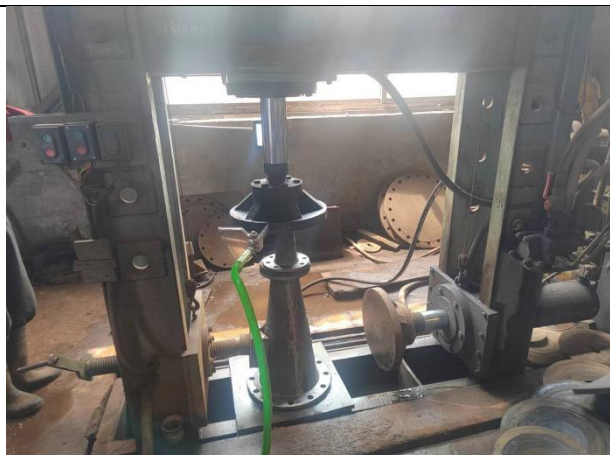
| Description:Witness water pressure test | | Description:Witness water pressure test |

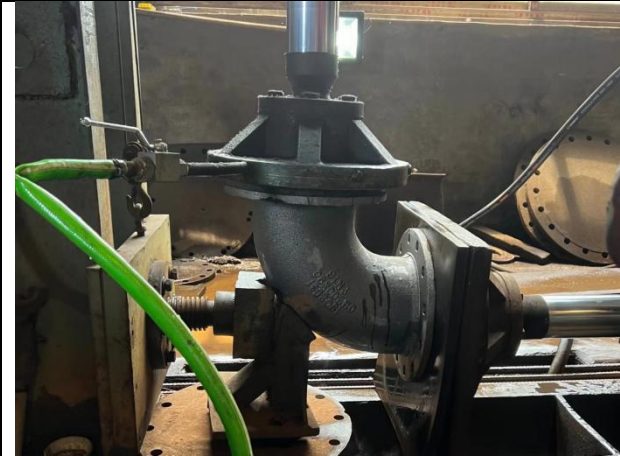
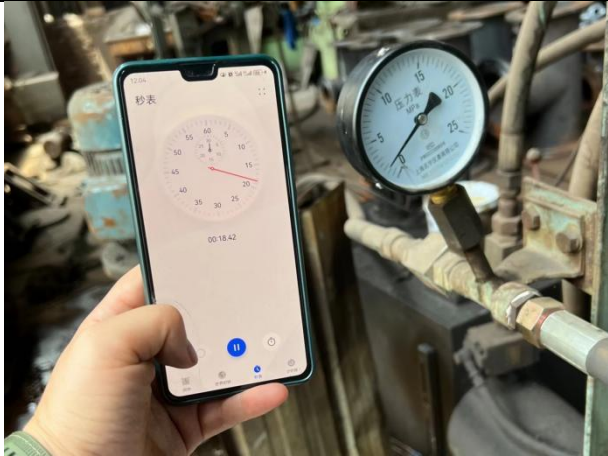
| | Description:Witness water pressure test | |
| | Description:Witness water pressure test | |

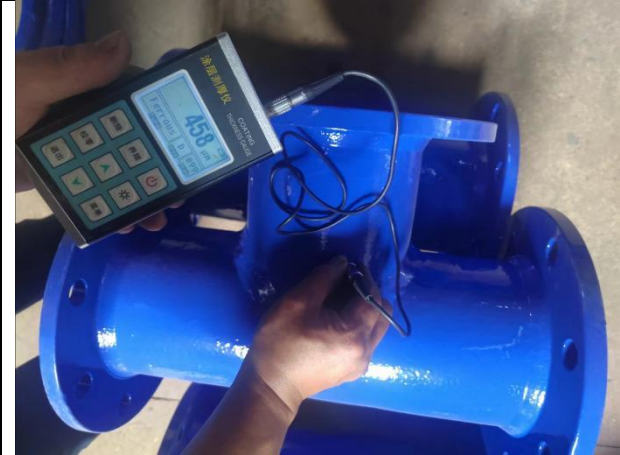
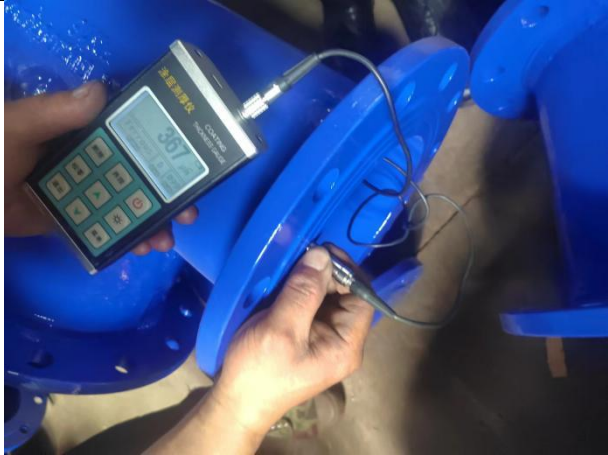
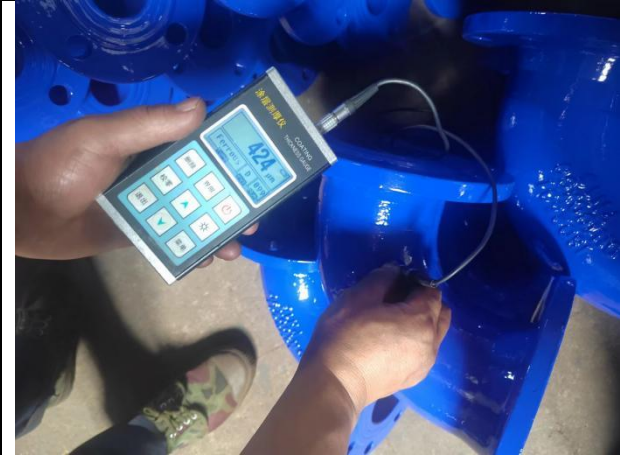
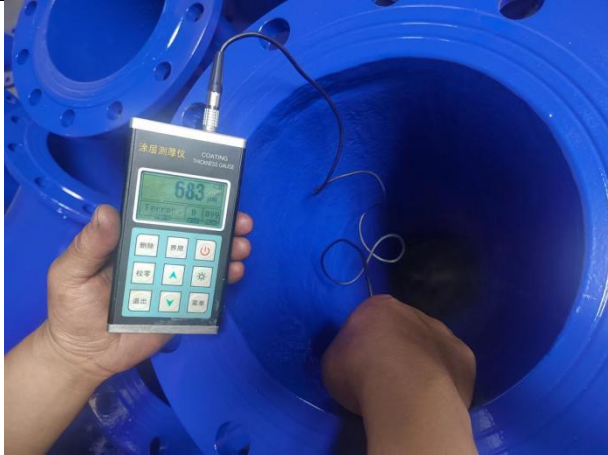
| | Description: Coating thickness check | |
| | Description:Coating thickness check | |
| | Description: Coating thickness check | |
| | Description:Coating thickness check | |

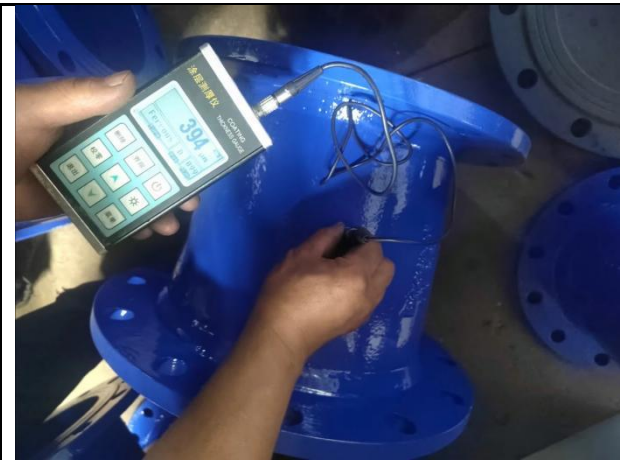
| INSPECTION REPORT No. INS/ER/MSS-24/064-20240627-01 | | Revision No.0 |
|---|---|---|
| Description: Coating thickness check | Description:Witness testing | |

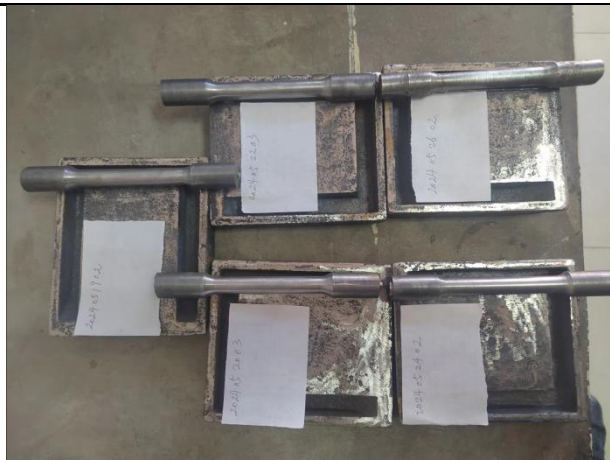
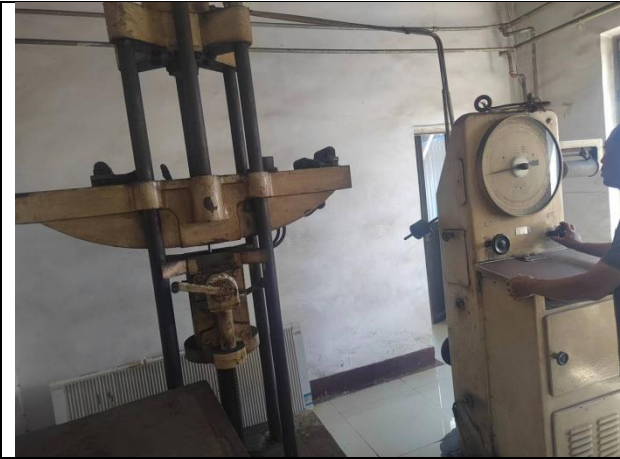
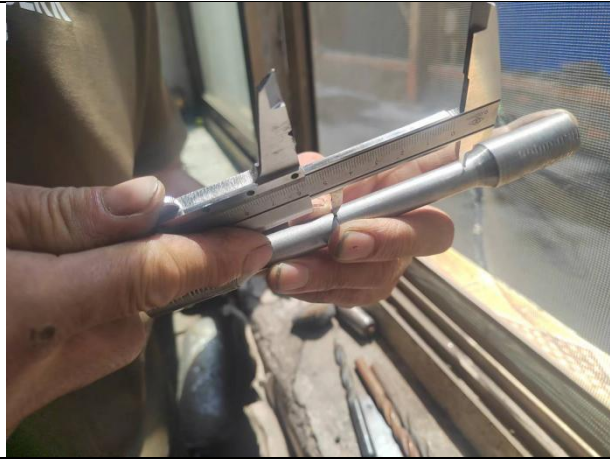
| INSPECTION REPORT No. INS/ER/MSS-24/064-20240627-01 | | Revision No.0 |
|---|---|---|
| Description:Witness tensile testing | Description:Witness tensile testing | |

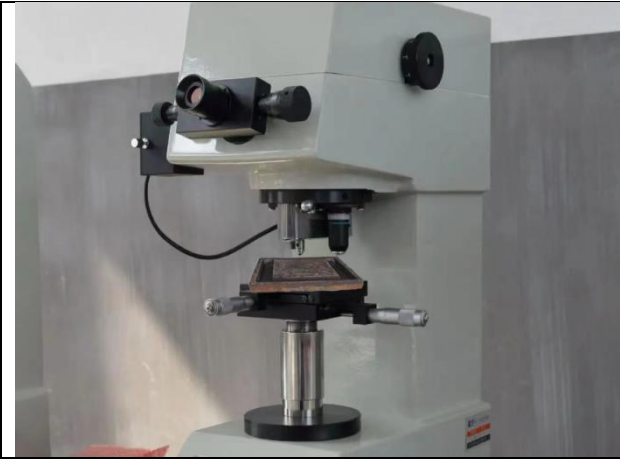
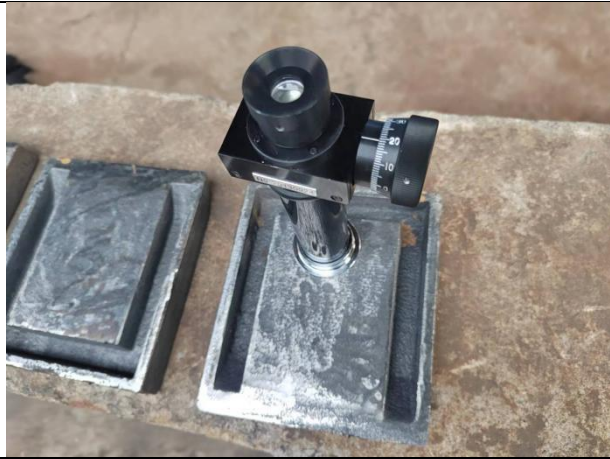
| INSPECTION REPORT No. INS/ER/MSS-24/064-20240627-01 | | Revision No.0 |
|---|---|---|
| Description:Witness hardness testing | Description:Witness hardness testing | |
